# Three Unit Product Ready for Delivery

# Three Unit Product Under Construction

Three Unit Lavatory Building With ADA Unisex - Women's and Shower Unit

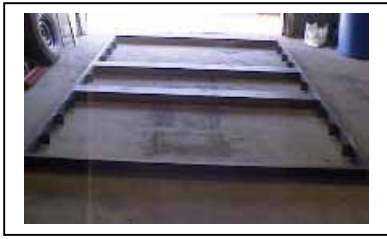
Fig. 1 Steel Frame with Tine Ports

The steel tine ports are the full length of the frame for increased mobility.  
Frame is 13' x 7.5' and weighs approximately 840 pounds.  
Frame is painted with a plastic base paint.

## Figure. 1 Steel Frame with Tine Ports

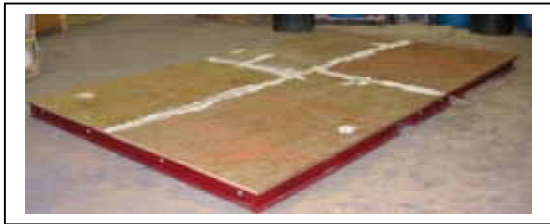
Fig. 2a ¾ Inch Plywood Decking for Floor

The treated ¾" exterior plywood floor is bolted to the frame and 2" x 4" boards.

### Figure. 2a. Wood Floor

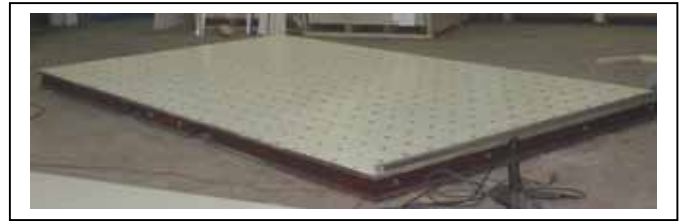
Fig. 3 Linoleum Covered Floor

The wood floor is covered with linoleum. The floor must set for 24 hours before the side walls can be put in place.

## Figure. 3. Linoleum Covered Floor

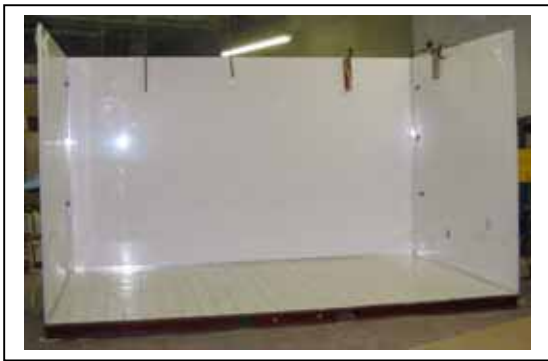
Fig. 4. Three Walls On Floor

The extrusions and outer walls are put in place and must set for 24 hours.

## Figure. 4. The outer walls are put in place.

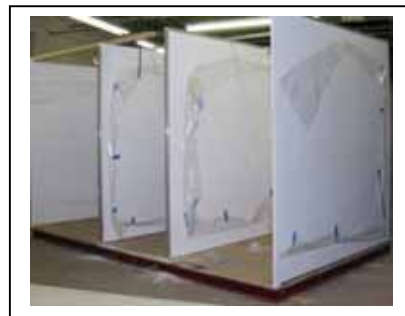
Fig. 4a Divider Walls Installed

The extrusions and inner walls are put in place and must set for 24 hours.

## Figure. 4a. The divider walls are put in place.

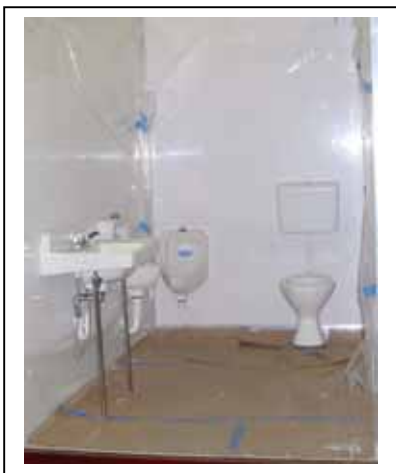
Fig. 5 ADA Stall with Urinals

The ADA Sink and Two Urinals are installed (one lowered for small children).  
The patented toilet bowl and cistern are installed.

## Figure. 5. The Inner Walls and ADA Unit Fixtures are Installed.

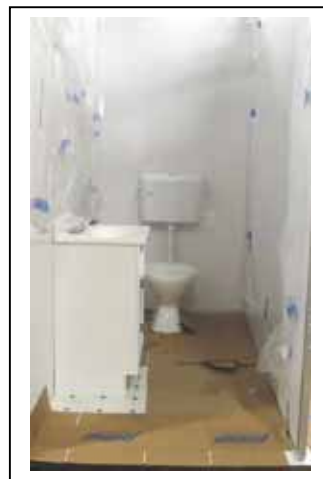
Fig. 6. Woman's Stall

The ladies stall is fitted with a vanity and patented toilet system.

## Figure. 6. Ladies Stall

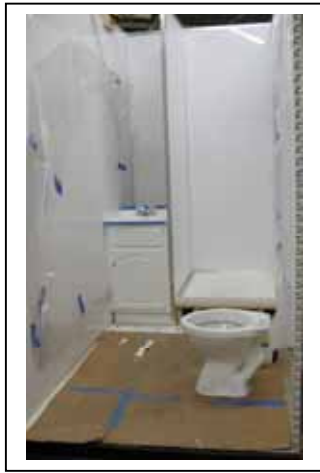
Fig. 7 Shower Stall

The shower unit is fitted with an inline hot water heater.

## Figure. 7. The third stall is fitted with a vanity, shower and patented toilet and cistern.

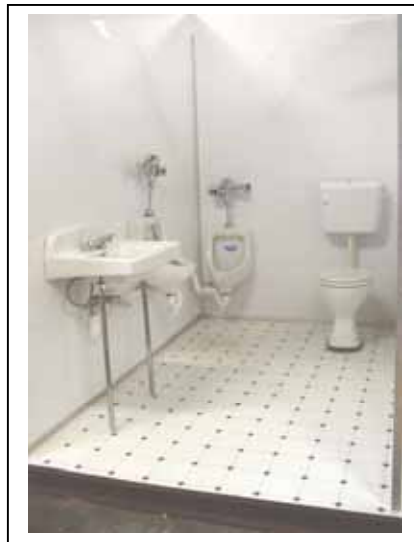
Fig. 8 ADA Unit With Auto Flushing Urinals

The urinals have been fitted with auto flushing mechanisms easier for child care.

## Figure. 8. ADA Unit With Two Urinals

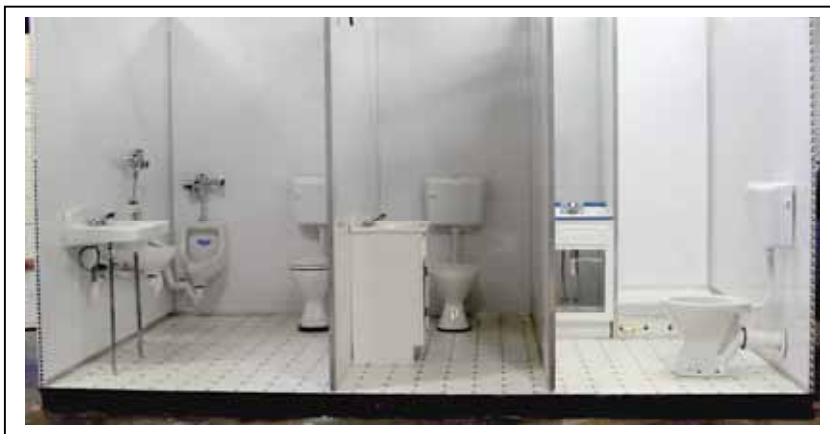
Fig. 11 Front View of Progress on 3 Stall Bldg.

The unit will weigh approximately 1,600 pounds upon completion

## Figure. 11. Progress on Three Stall Building Front View.

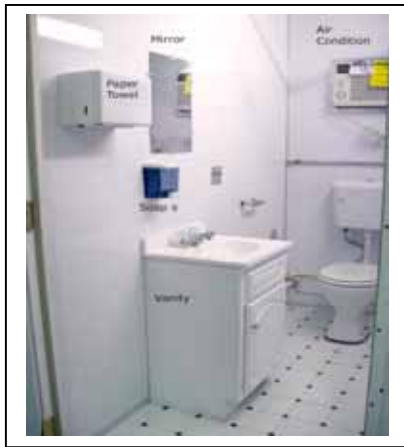
Fig. 12 Women's Unit Middle Stall

The middle section on this unit is a women's unit with vanity.

## Figure. 12. Women's Middle Stall Completed

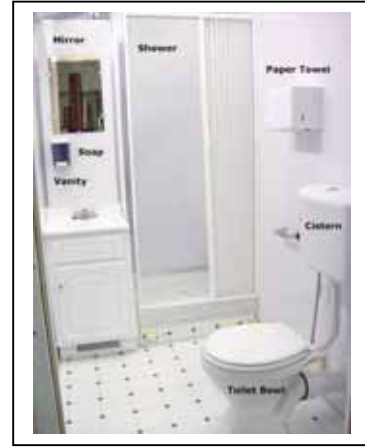
Fig. 13 Shower Stall/Lavatory Combo

The third unit is unisex hot water shower with lavatory and vanity.

## Figure. 13. Shower Stall and Lavatory Combination

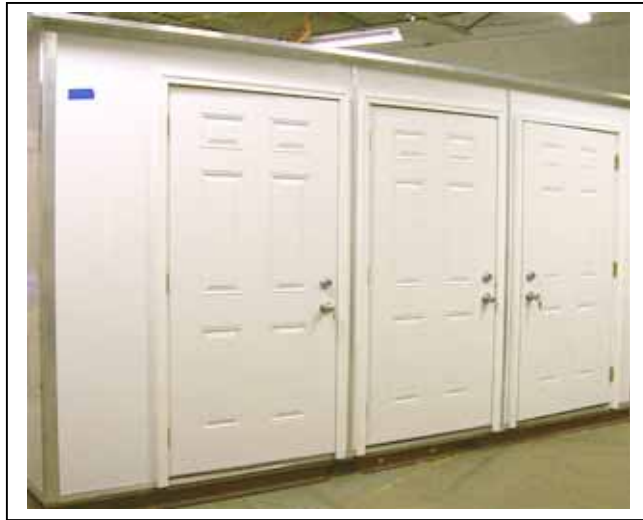
Fig. 14 Front Building Finished With Doors Closed

The three stall unit contains one ADA compliant stall, one women's stall and one combination shower and lavatory stall.

## Figure. 14. The Three Stall Unit With Closed Doors

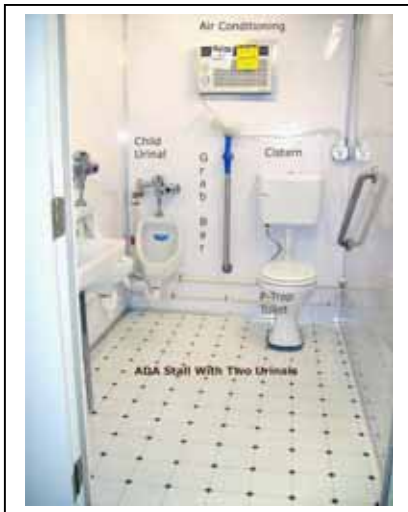
Fig. 15 ADA Unit Completed

This ADA compliant unit has two urinals, one for children and one for adults.

## Figure. 15. The Unisex ADA Compliant Stall With Two Urinals
